ORNL/Sub/84-47992/1

**High Temperature Coating Study
to Reduce Contact Stress
Damage of Ceramics**

Final Report

Prepared by
Garrett Turbine Engine Company
A Division of Garrett Corporation
2739 East Washington Street
P.O. Box 5217
Phoenix, Arizona 85010
Under Subcontract 86X-47992C

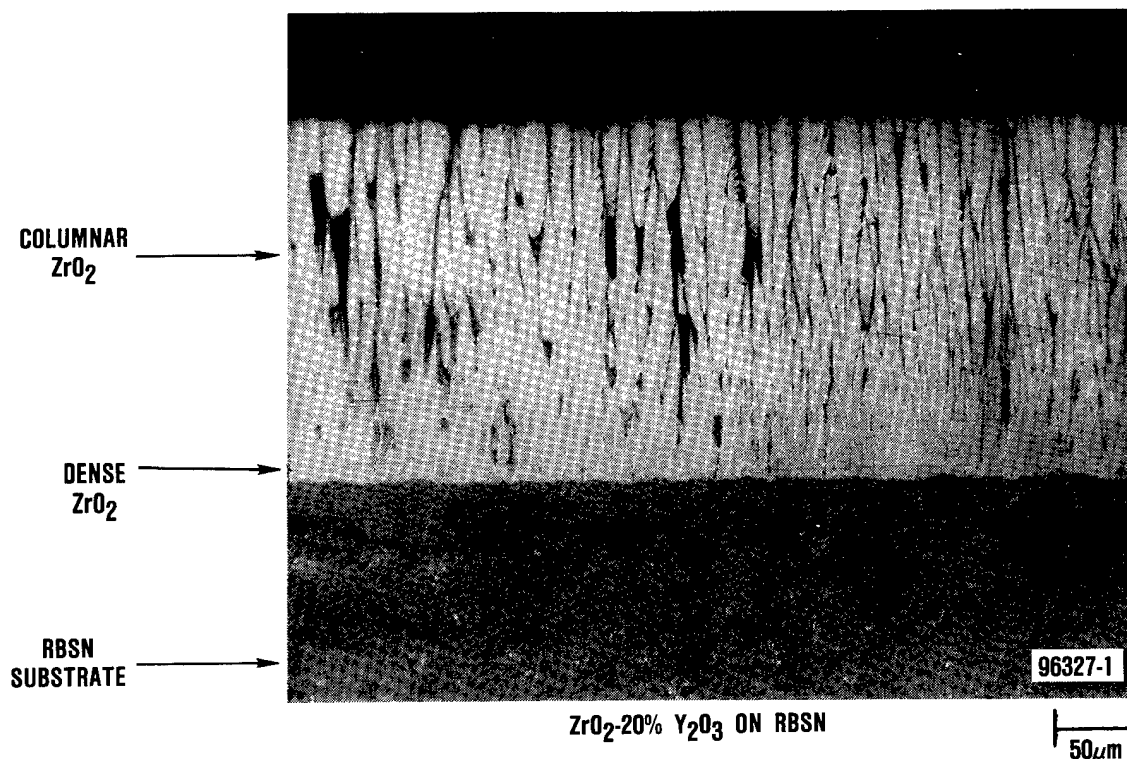
Figure 2. The EB-PVD zirconia coating grades from dense and microgranular at the interface to porous and columnar as it increases in thickness.

After pretreatment, the substrates were EB-PVD coated with 75 to 125 microns of zirconia stabilized with 20 percent yttria*. The coatings were applied at 980C. The initial few microns were deposited under oxygen deficient conditions (excess Zr) resulting in the thin, dense, equiaxed ZrO_2 coating desired for bonding. Oxygen was then introduced into the coating chamber resulting in a columnar microstructure with intercolumnar porosity, a structure which had an improved strain tolerance and compliance. The EB-PVD Y_2O_3 stabilized ZrO_2 microstructure is illustrated in Figure 2.

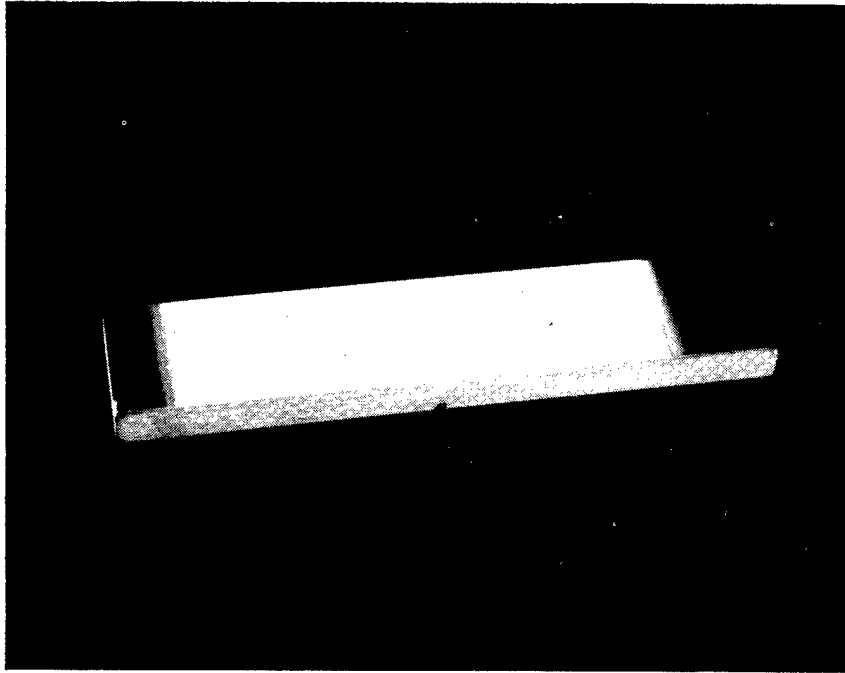
Figure 3. The EB-PVD zirconia appeared adherent to the substrates in the as-coated condition.

in Figure 3. The coatings varied in color, ranging from white to blue or gray. The color difference is typically associated with the stoichiometry of the ZrO_2 coating; white being stoichiometric and blue or gray being non-stoichiometric (oxygen deficient). In most cases the coatings were smooth and free of surface defects. Some specimens did exhibit small pits or bumps on the coatings which were attributed to "spitting" from the molten zirconia pool during coating. In some cases, the gray coatings were cracked or crazed. This effect could not be connected with any substrate, pretreatment or coating run.

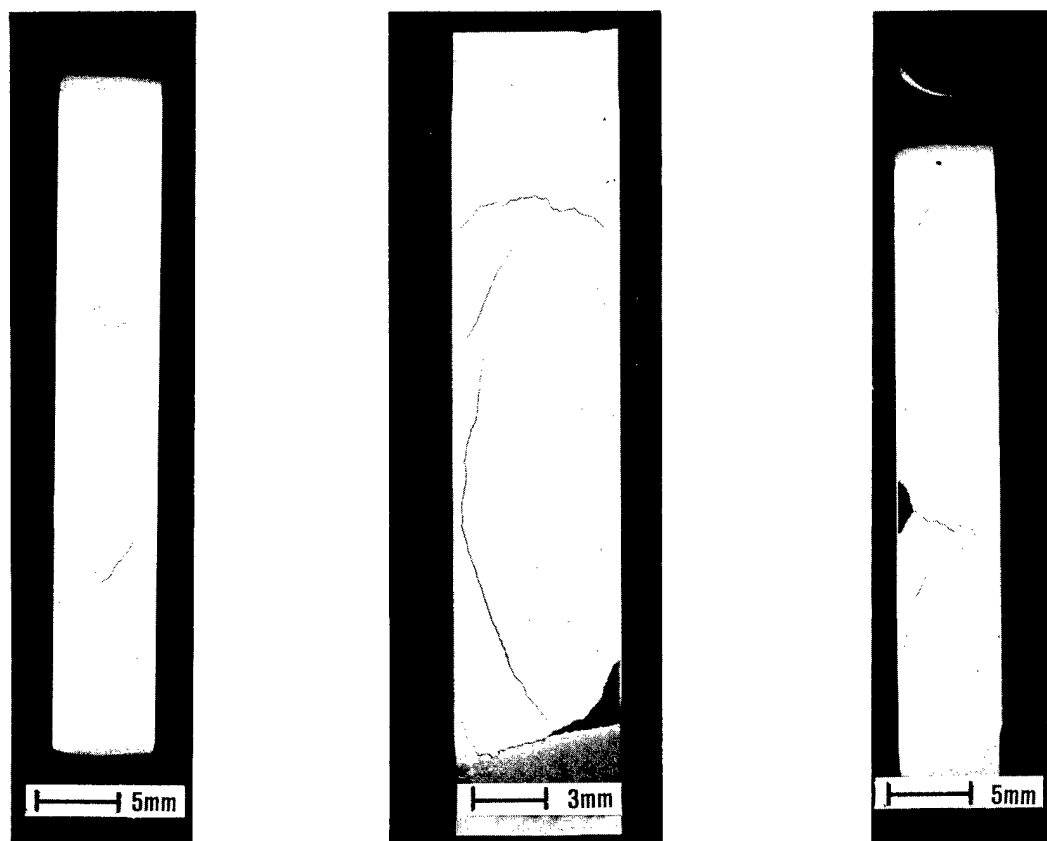
REACTION-BONDED Si_3N_4 SINTERED Si_3N_4 SINTERED SiC

Figure 4. Molybdenum interlayer specimens exhibited severe coating cracking during the ZrO_2 coatings on oxidation exposure.

ZrO₂ spalled off together in sheets. Based on these results, the cause of spalling appears to be due to a thermal expansion mismatch or due to Mo reacting with the substrate and/or the coating. For all other coating/substrate systems, the ZrO₂ coating appeared clean and adherent after oxidation.

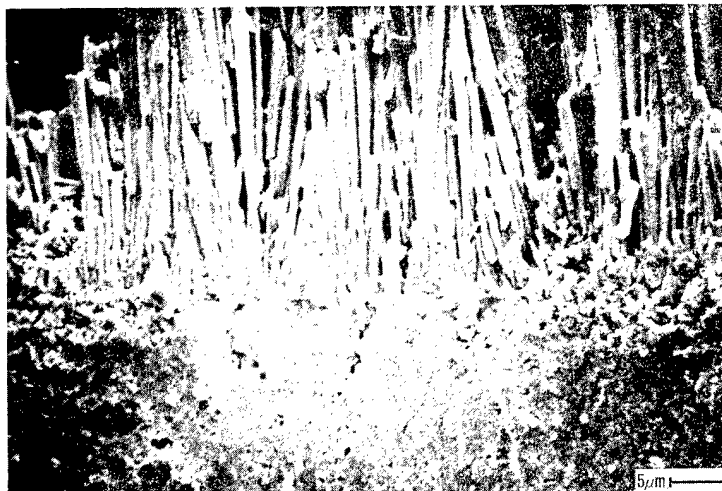
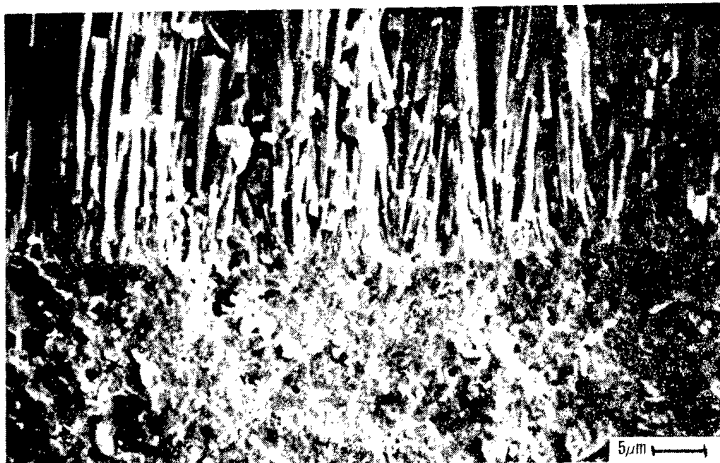
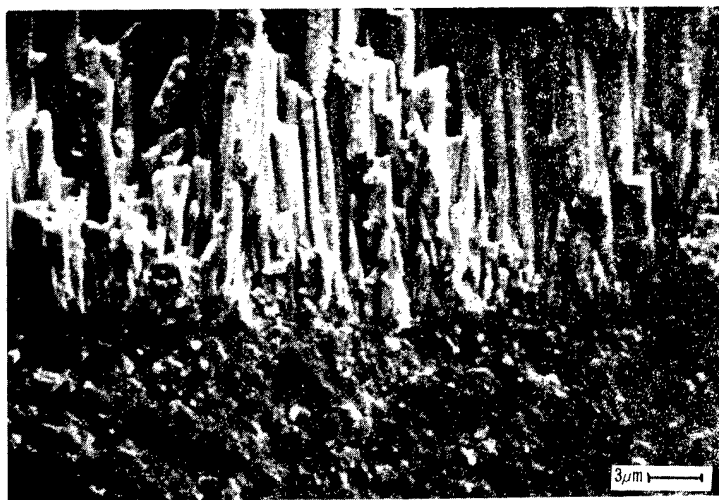
← ZrO₂ COATING

← AS-MACHINED RBSN
SUBSTRATE

← HEAVILY-PREOXIDIZED
RBSN SUBSTRATE

Figure 5. As-coated zirconia remained adherent to RBSN substrates with various pretreatments through flexure testing.

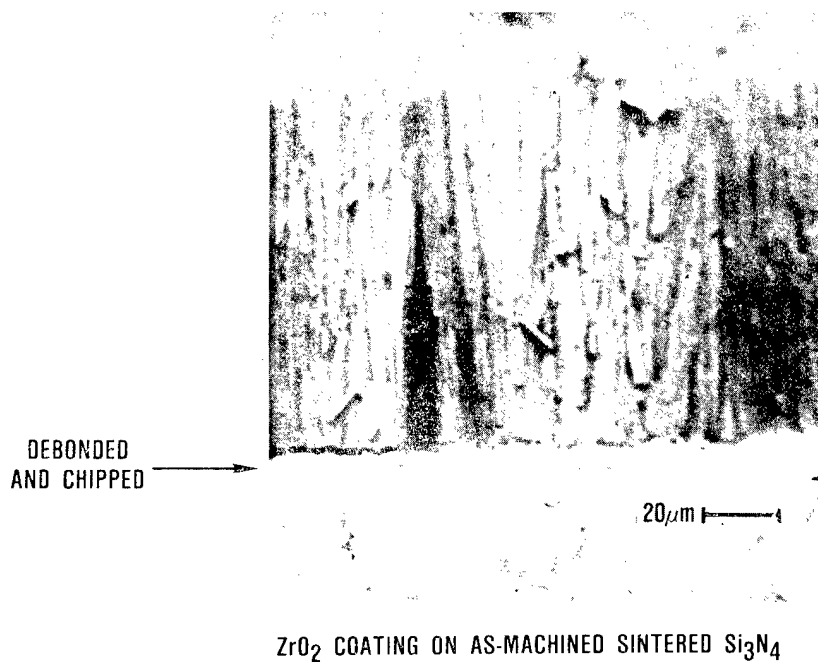
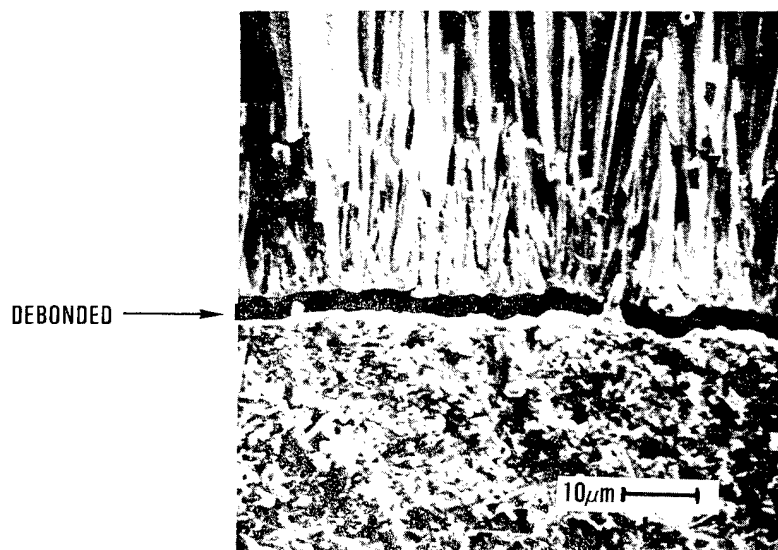
Figure 6. In some instances, flexure testing resulted in debonding and/or chipping of zirconia coatings on sintered silicon nitride substrates.

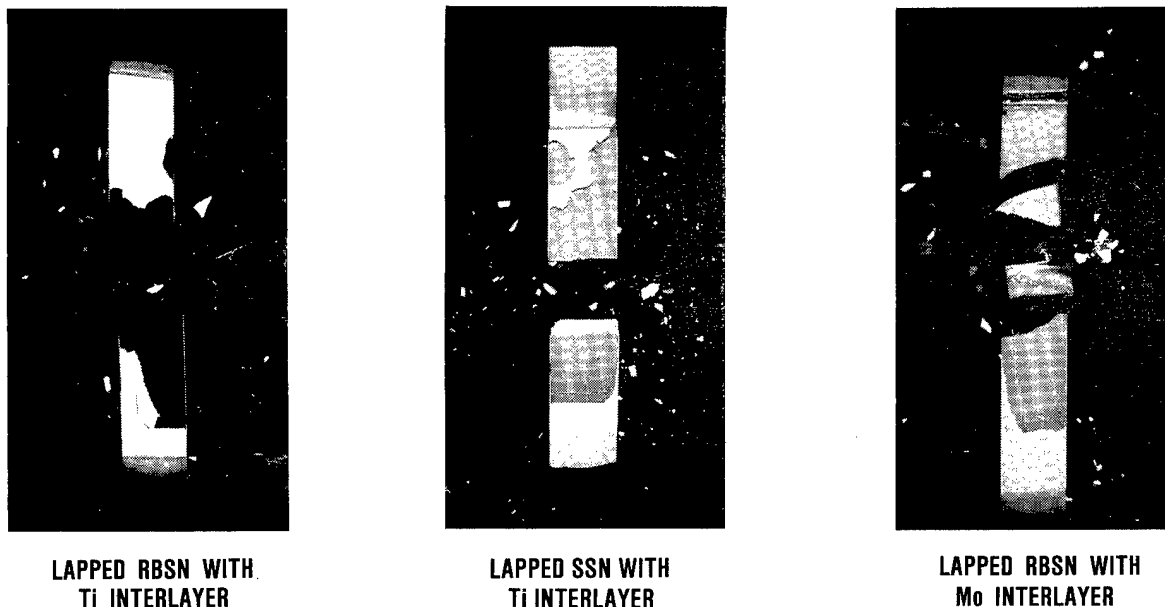
Figure 7. The worst zirconia adherence was observed for lapped substrates with metallic interlayers.

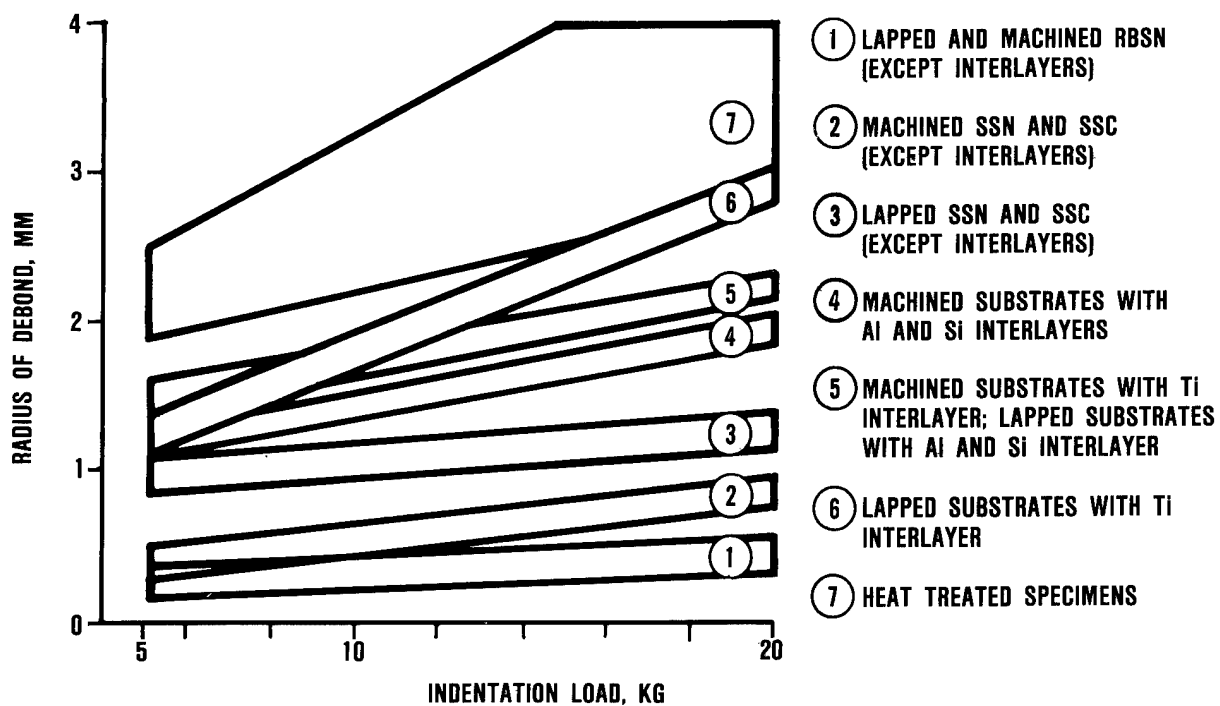
Figure 8. Indentation results are summarized plotting the radius of debond versus indentation load. The highest curve (#7) represent poorest observed, the lowest curve (#1) represents the best adherence.

The indentation test results are summarized in Figure 8, where the average radius of the debonded area is plotted as a function of the indentation load. The range of debonding observed is illustrated in Figure 9. The results are in agreement with those obtained by scratch testing and flexure testing. The best coating adherence was observed for RBSN (both machined and lapped) with pre-oxidation or

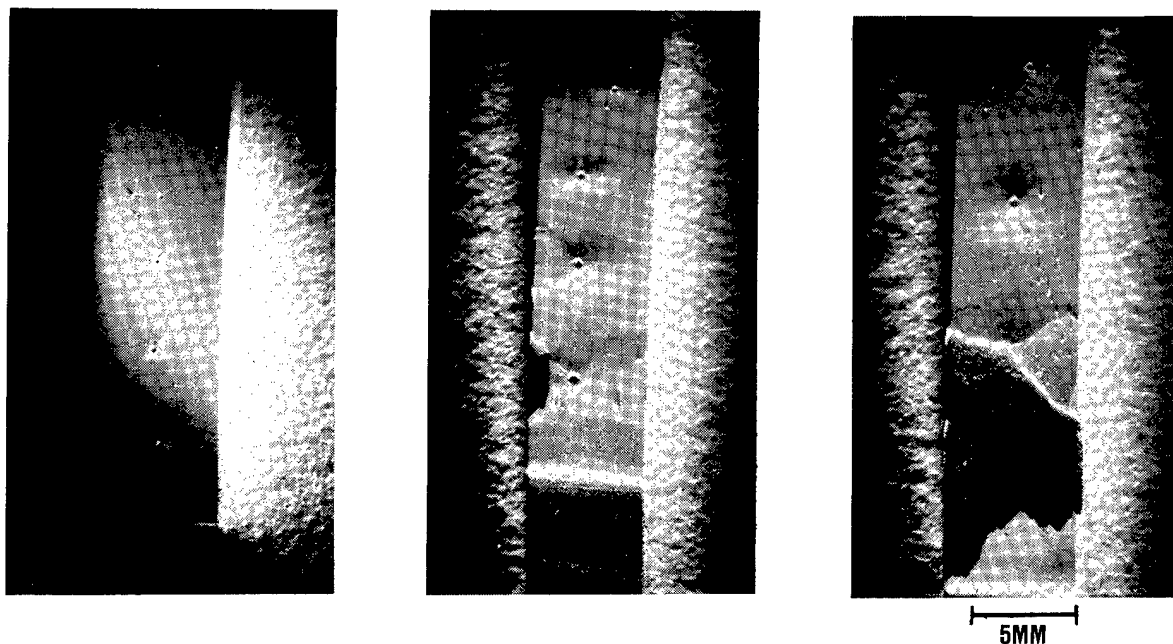
Figure 9. Indentation testing provided the range of debonding observed above.

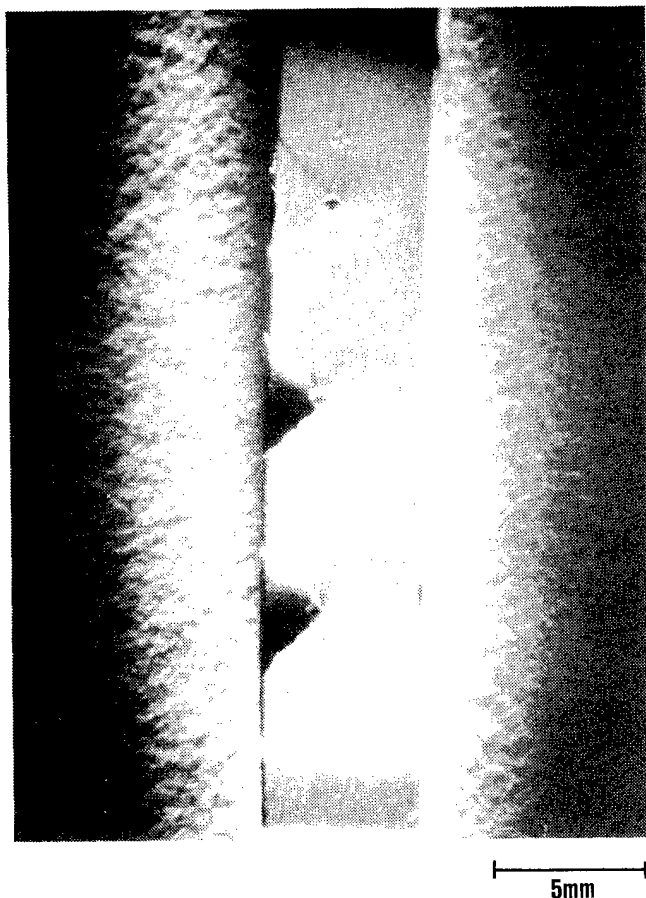
Figure 10. Many-heat treated specimens exhibited debonding that extended to the edges of the specimen and therefore did not provide comparative information.

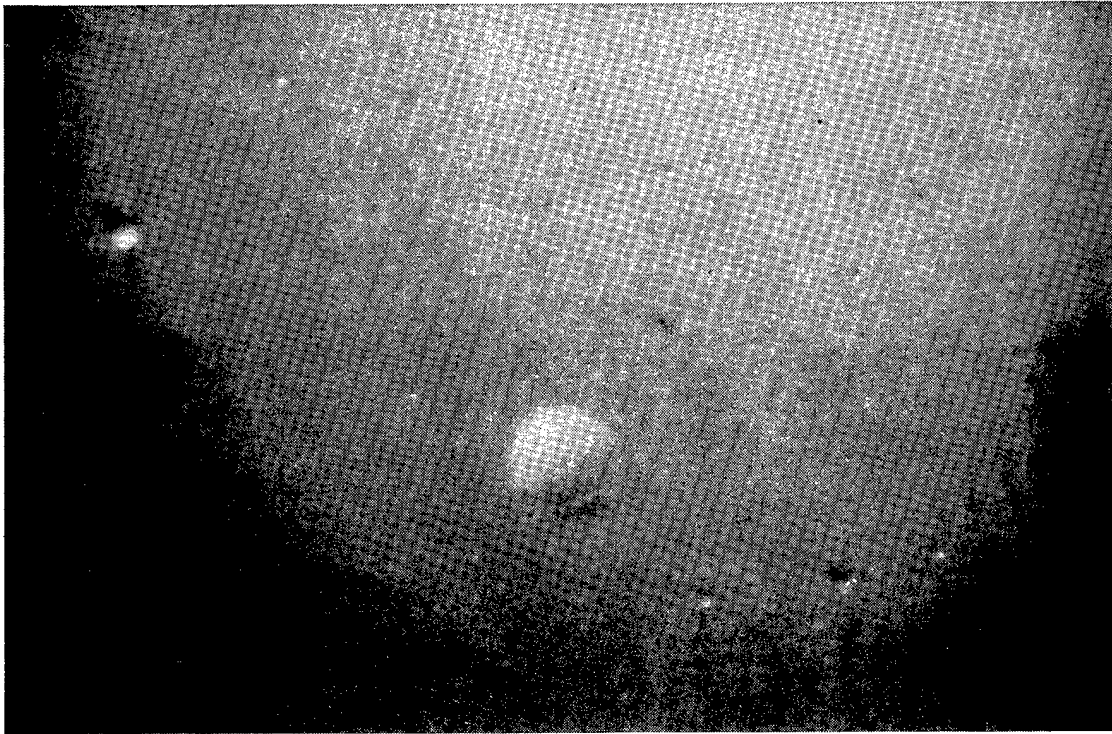
Figure 11. A 20 kg ball indentation provides no information for assessing coating adherence. No damage, other than deformation of the coating, occurred.

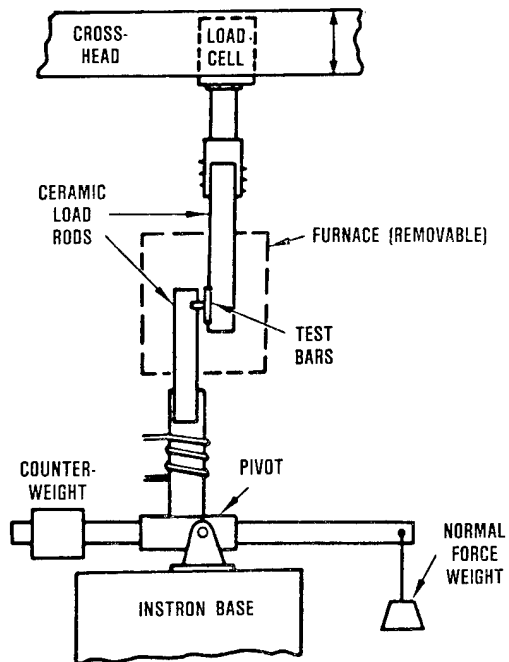
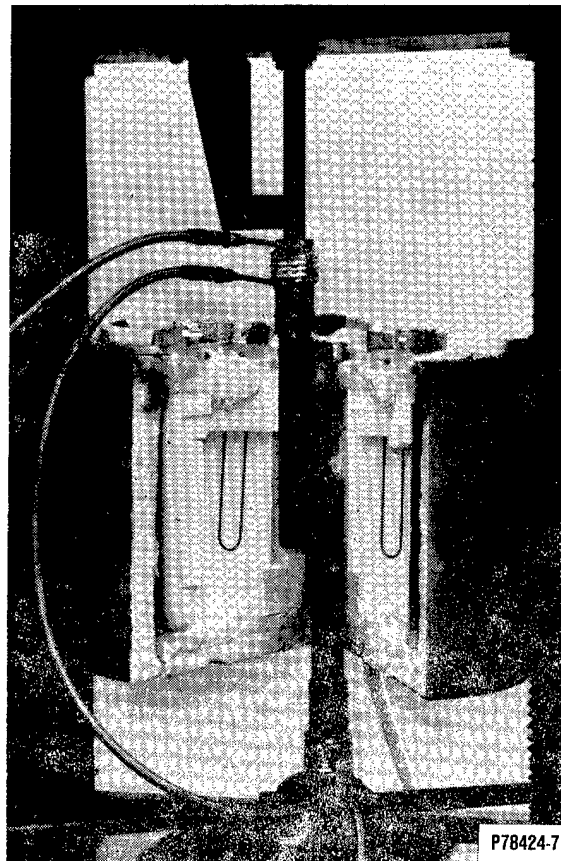
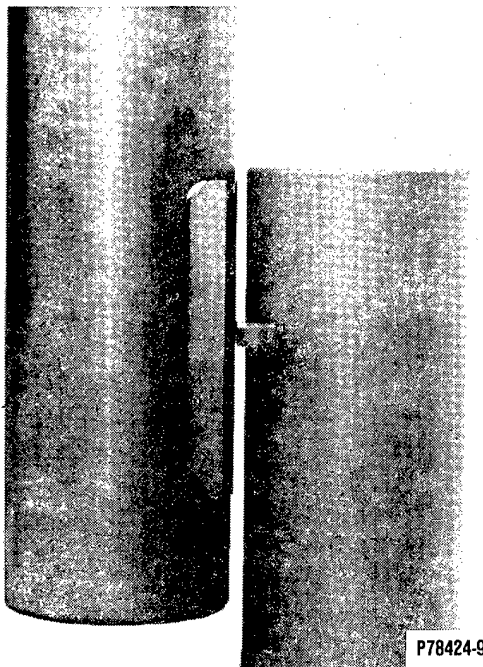
Figure 12. The GTEC Contact Test Rig applies a normal load through a dead weight loading system while a tangential force is applied through displacement of the Instron crosshead.

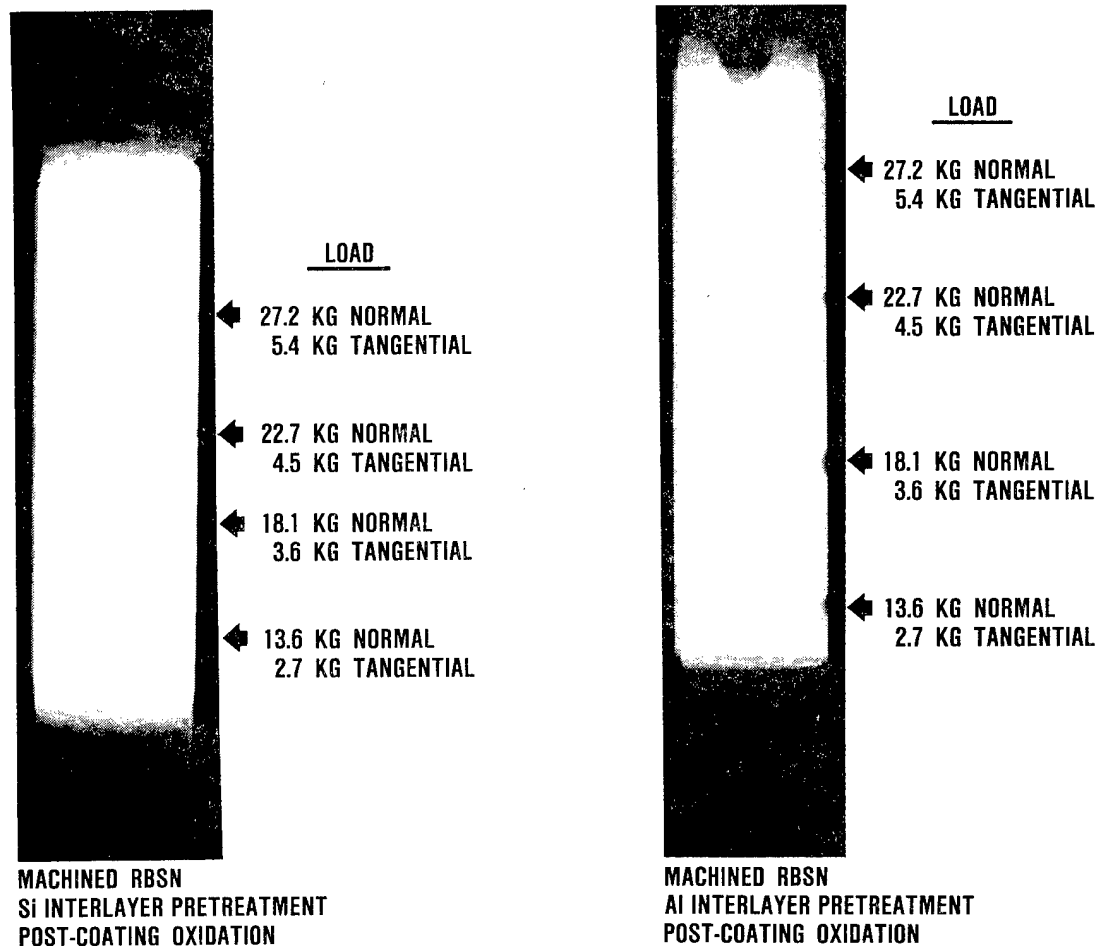
Figure 13. No significant damage to the coatings occurred during static line contact testing. The specimens shown above have relatively poor coating adherence based on results from scratch, flexure, and indentation tests.

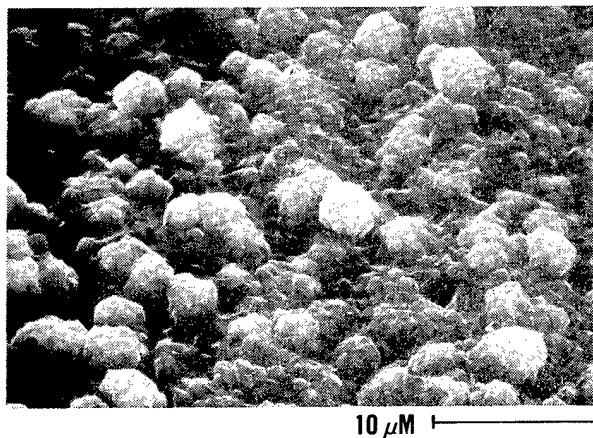
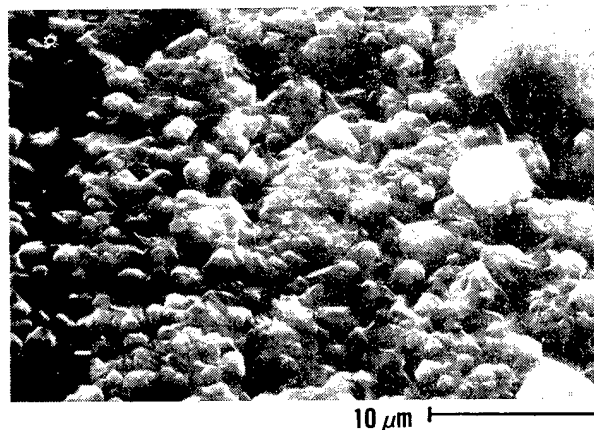
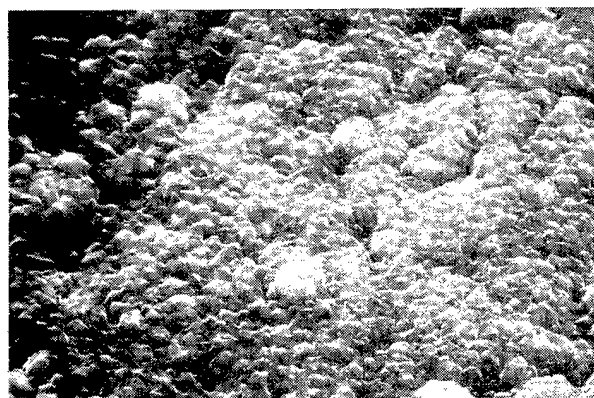
CVD- Al_2O_3 ON RBSN

CVD- Al_2O_3 ON SSN

CVD- Al_2O_3 ON SSC

Figure 16. The microstructure of CVD alumina consists of nodular grains, one to three microns in size.

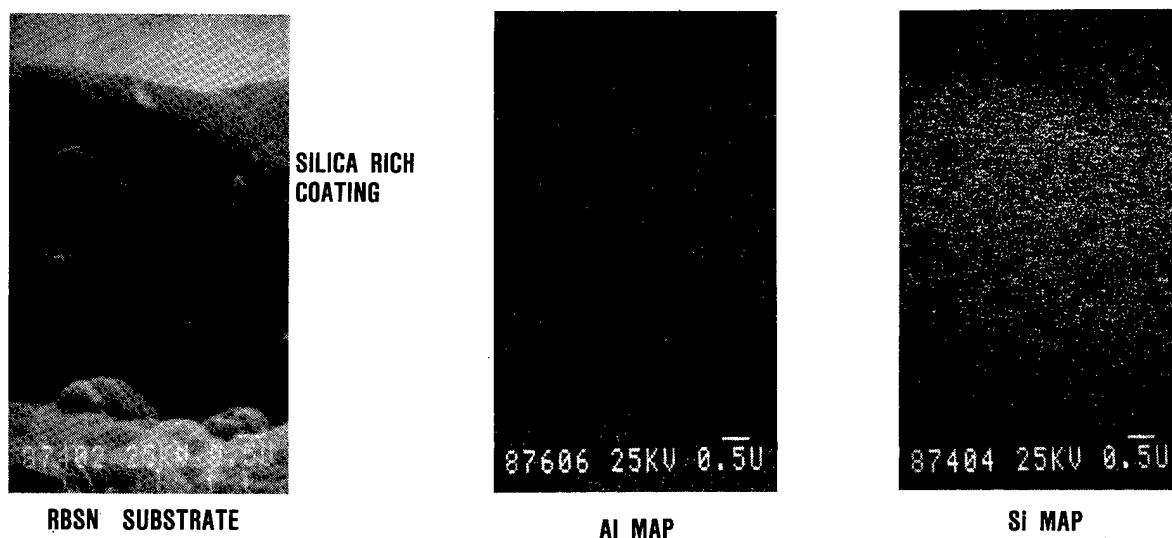
Figure 18. EB-PVD coating runs using 80 weight percent Al_2O_3 and 20 weight percent SiO_2 as a material source resulted in thin, dense, non-columnar, silica rich films.

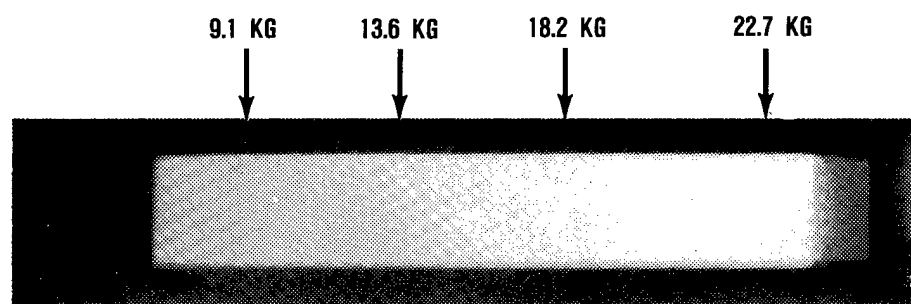
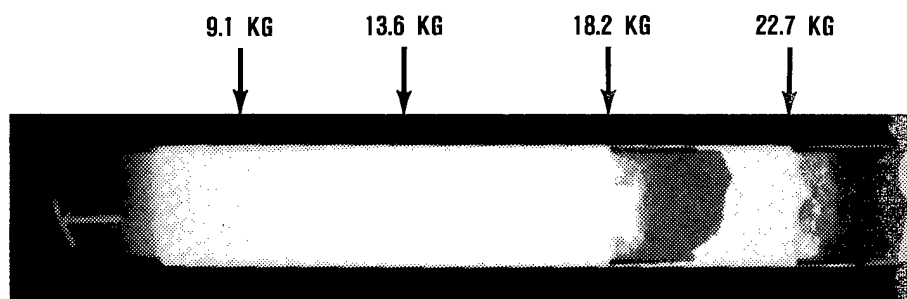
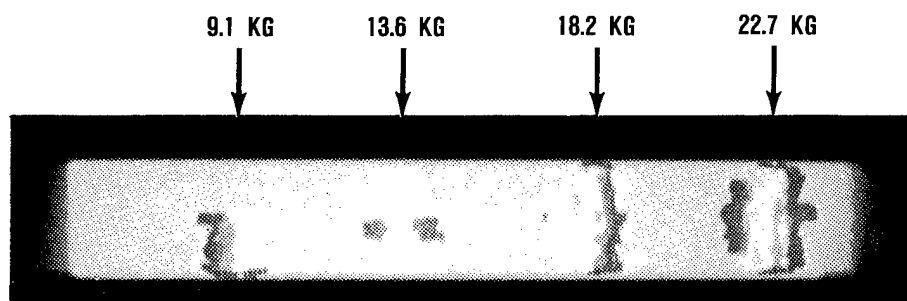
EXCELLENT ADHERENCE

FAIR ADHERENCE

POOR ADHERENCE

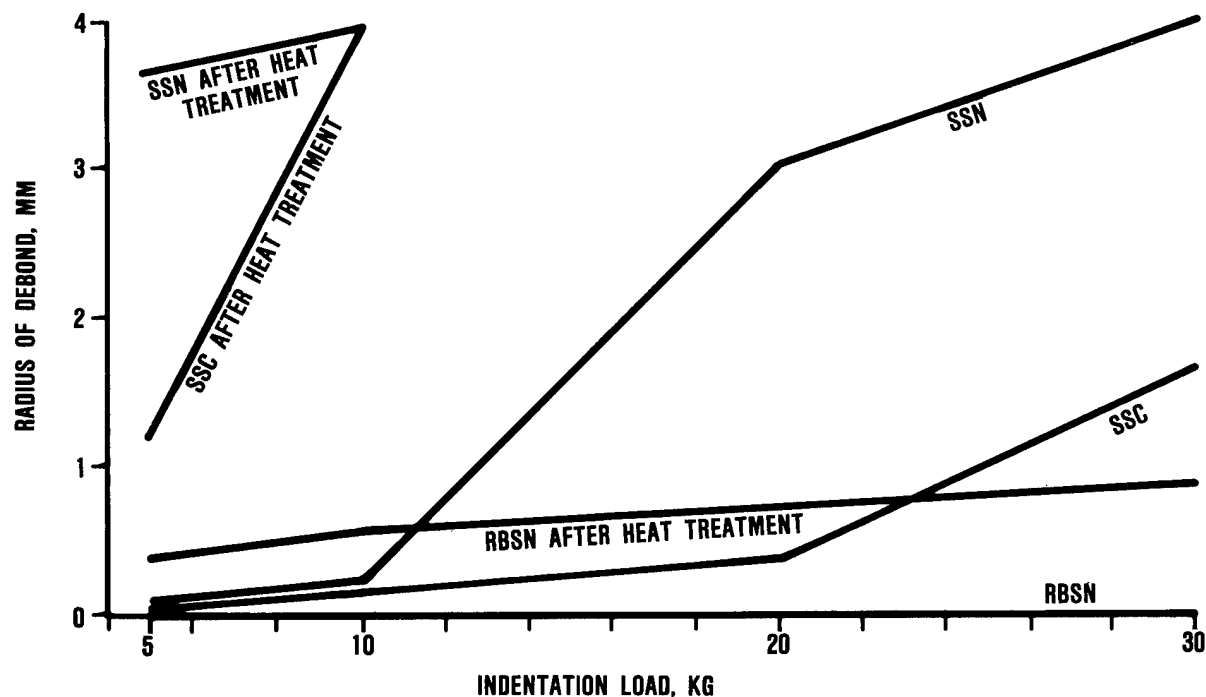
Figure 20. RBSN specimens with CVD Al_2O_3 interlayers exhibited excellent adherence before and after oxidation heat treatment.

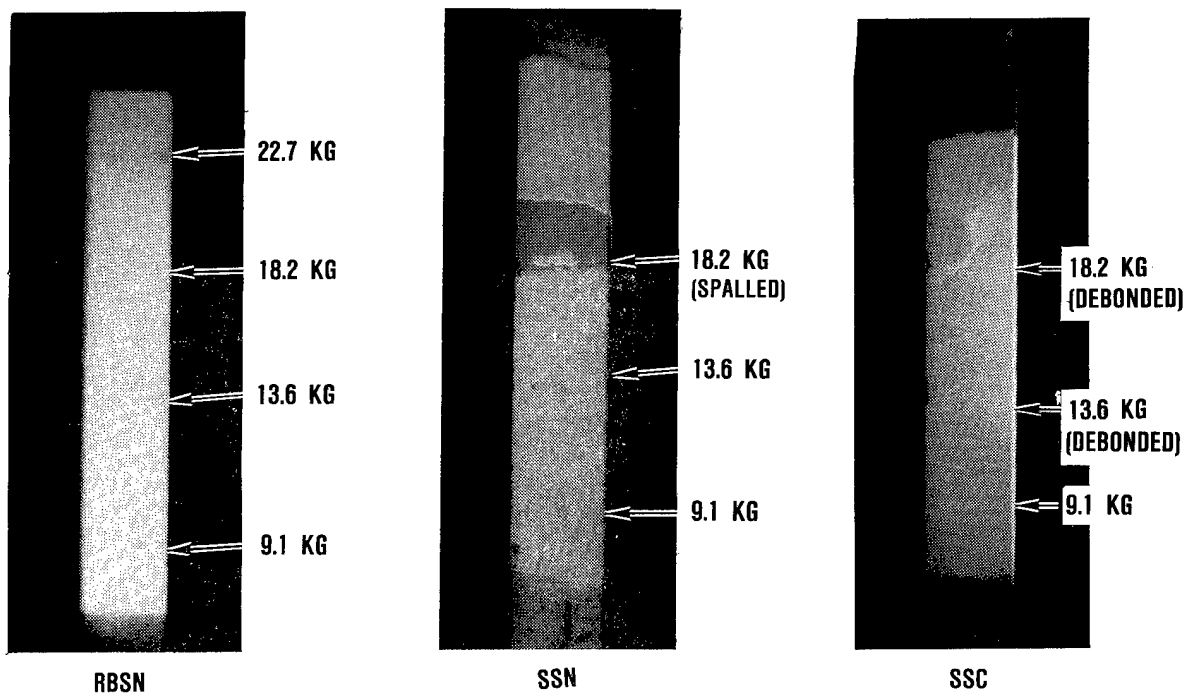
Figure 21. Contact testing results of oxidized CVD alumina interlayer specimens show excellent adherence for RBSN, fair adherence for SSN, and poor adherence for SSC.

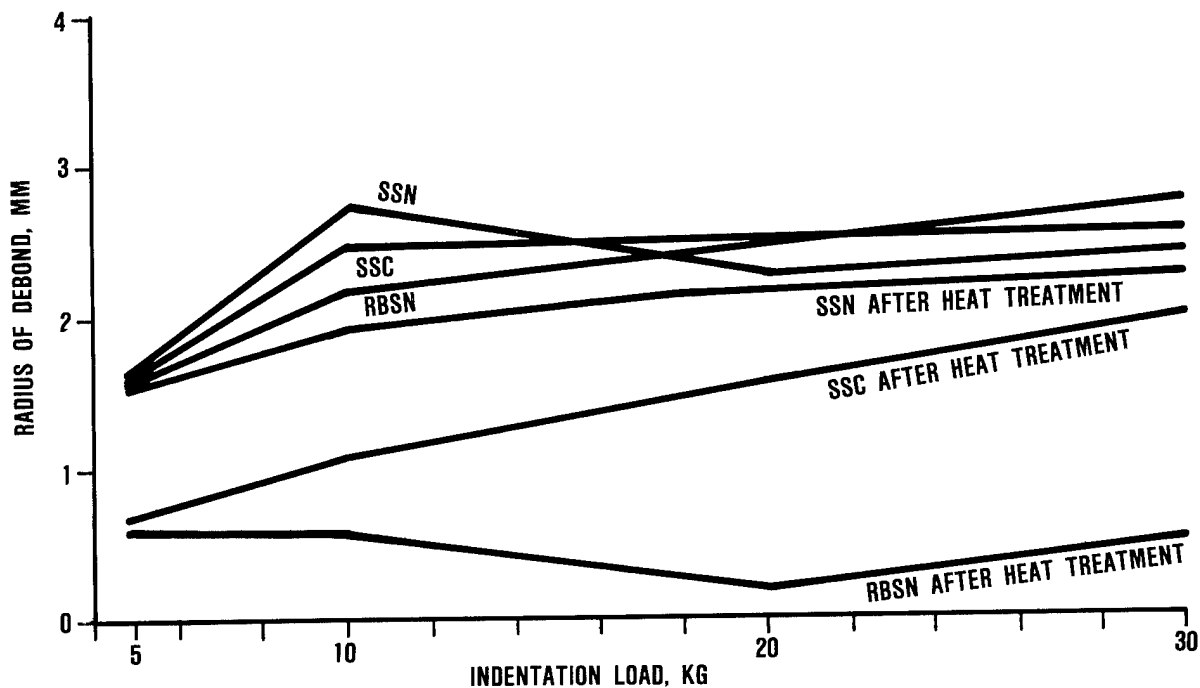
Figure 22. The adherence for $\text{ZrO}_2/\text{CVD AlN/RBSN}$ increased significantly after heat treatment.

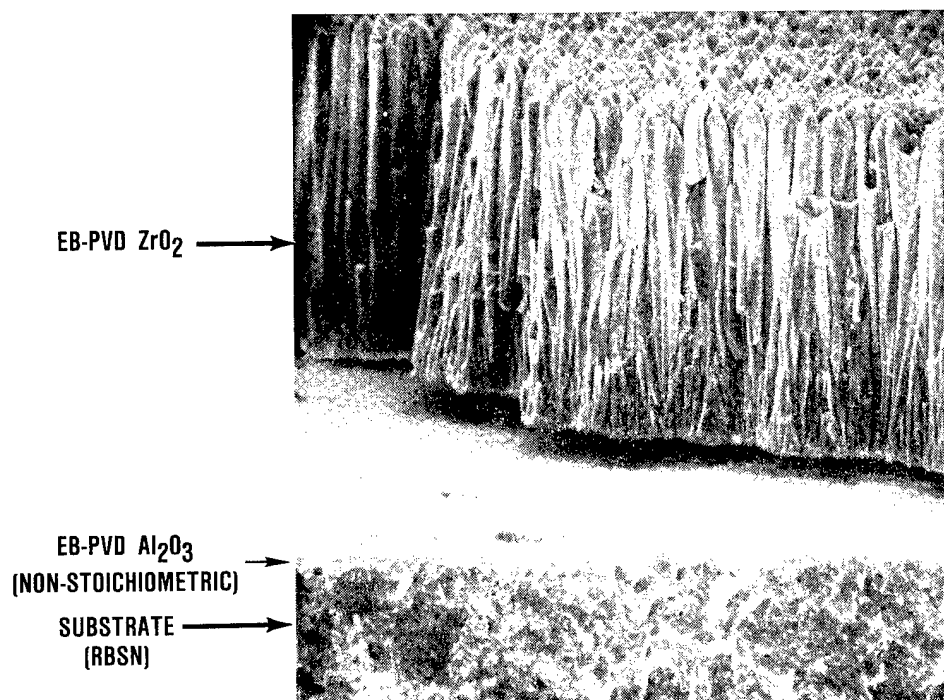
Figure 24. Zirconia coatings typically spalled from the non-stoichiometric EB-PVD alumina interlayers during flexure testing.

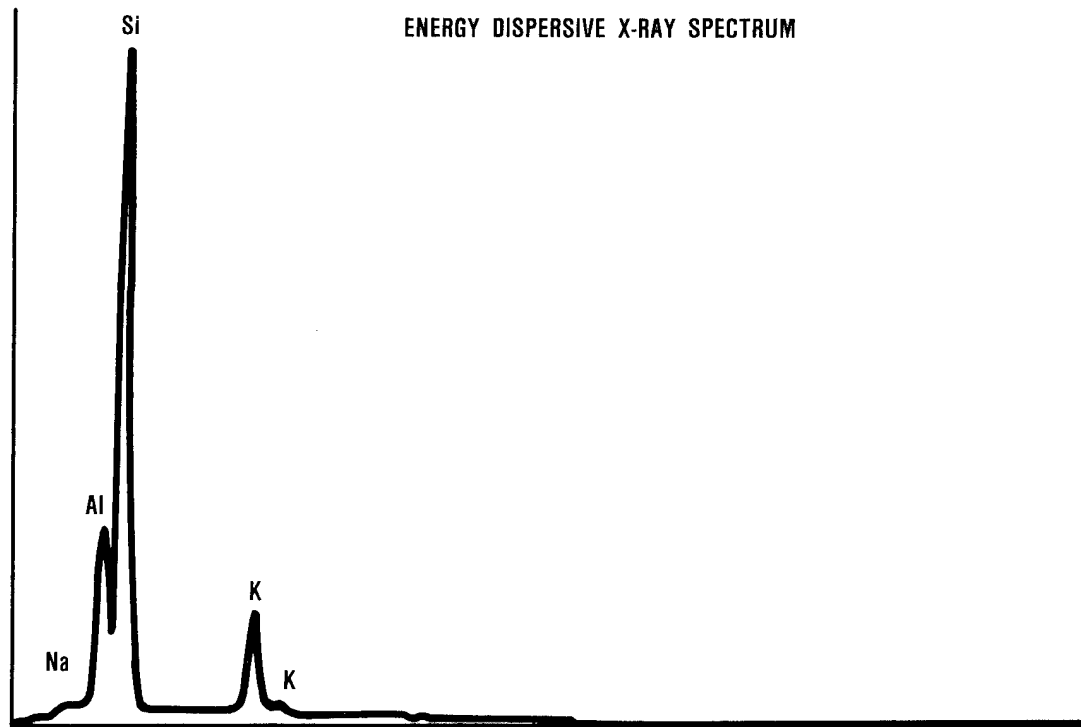
Figure 25. EDX analysis of spalled area suggests the non-stoichiometric alumina coatings were contaminated prior to EB-PVD zirconia application since sodium (Na) and potassium (K) were detected.

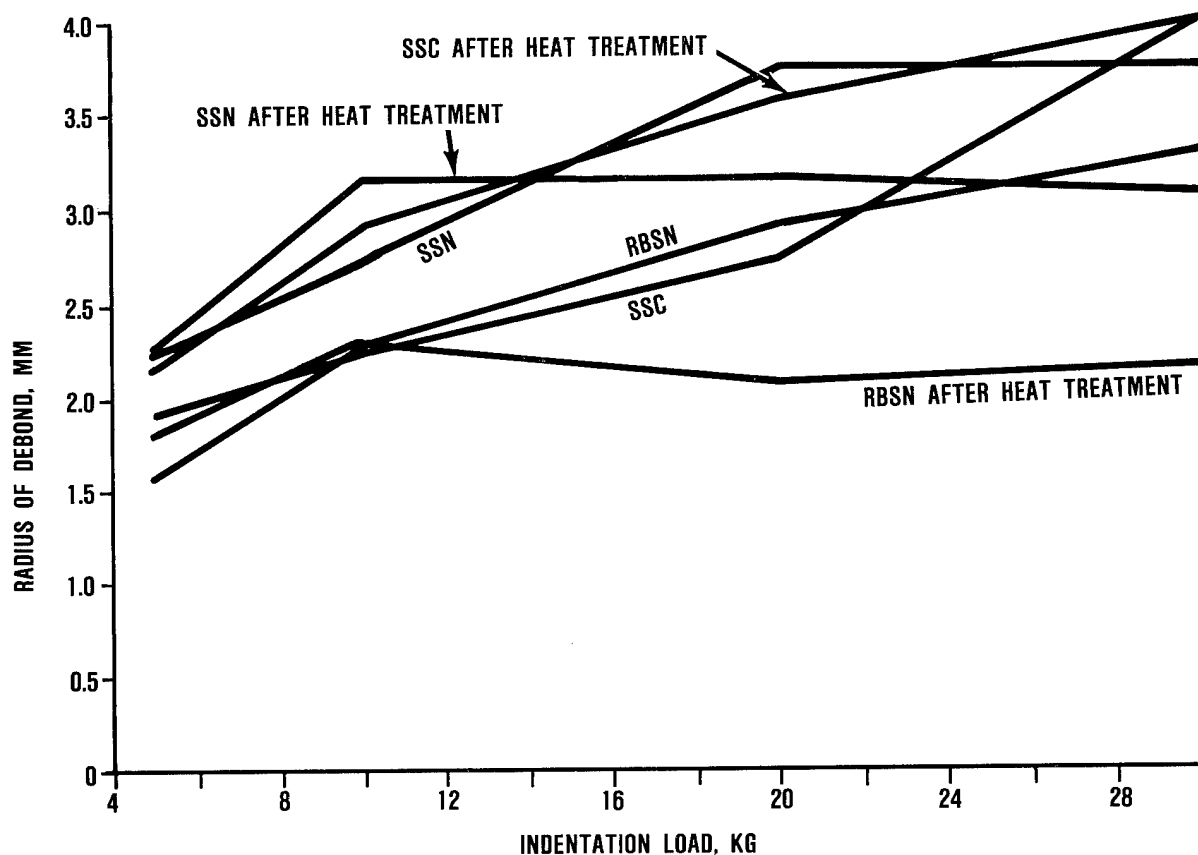
Figure 26. Stoichiometric EB-PVD interlayers resulted in relatively poor initial adherence.

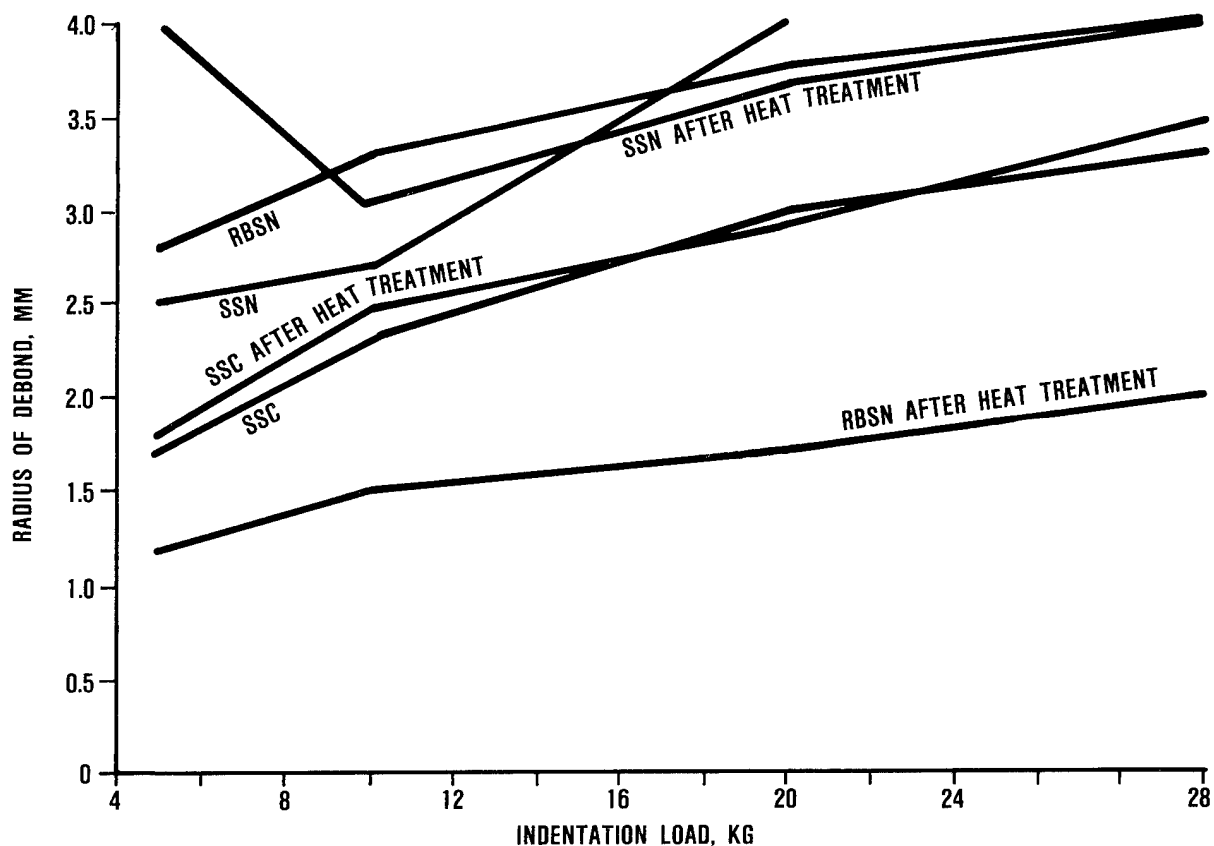
Figure 27. Non-stoichiometric EB-PVD Al_2O_3 interlayers resulted in poor initial coating adherence. The ZrO_2 adherence was slightly less than observed for stoichiometric EB-PVD Al_2O_3 .

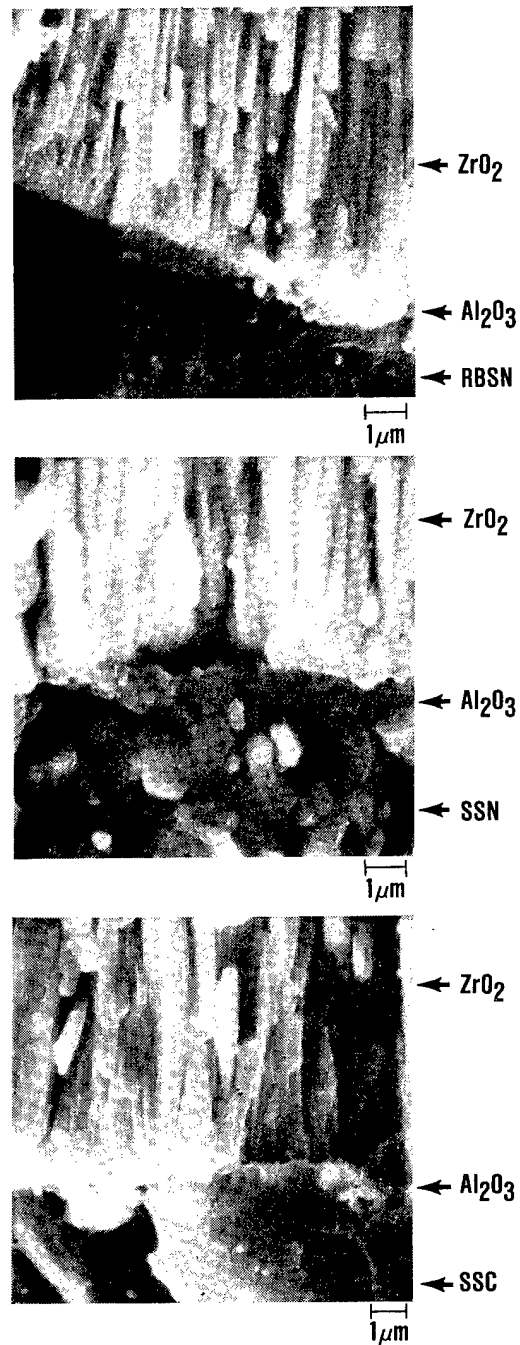
Figure 28. Fracture surfaces of sol-gel alumina interlayer specimens show the coating/interlayer/substrate interfaces exhibiting intimate contact.

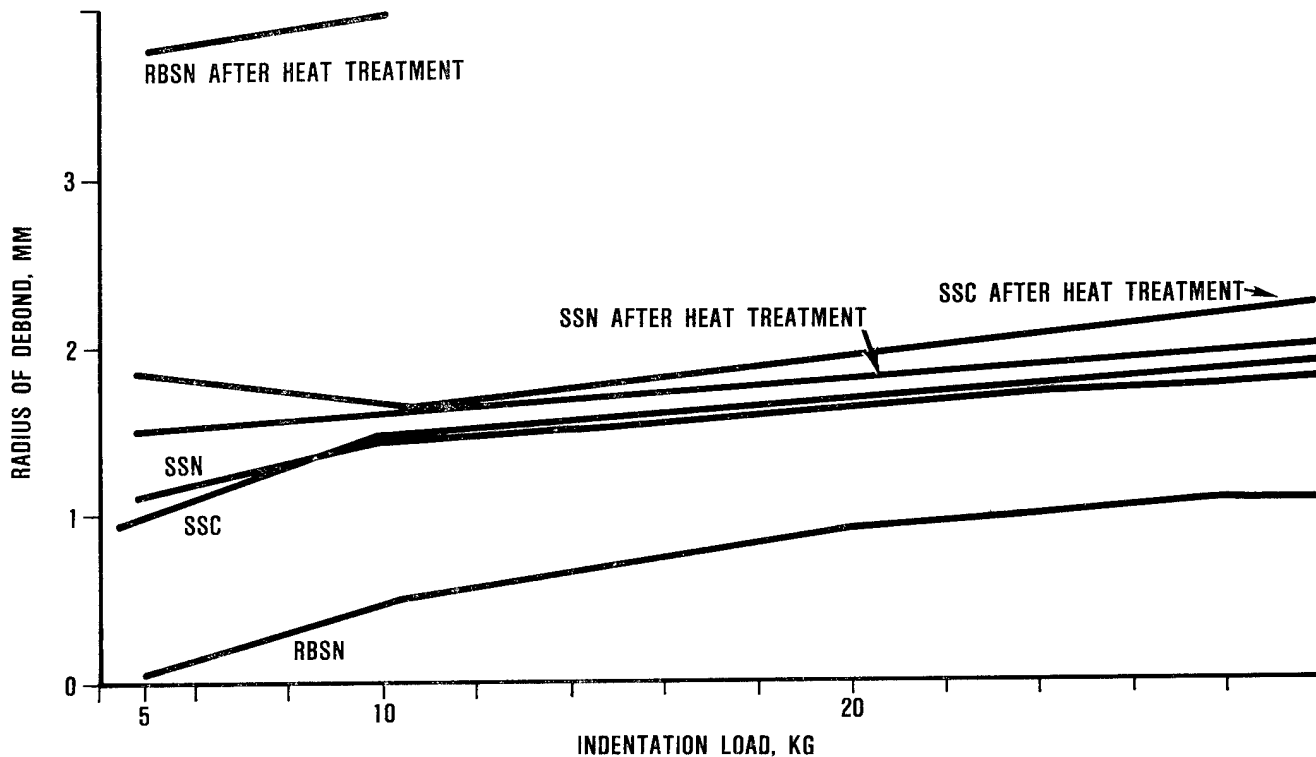
Figure 29. Sol-gel Al_2O_3 interlayers yielded fair adherence for SSN and SSC which was retained through heat treatment. RBSN exhibited excellent initial adherence but exhibited a large adherence loss on heat treatment.

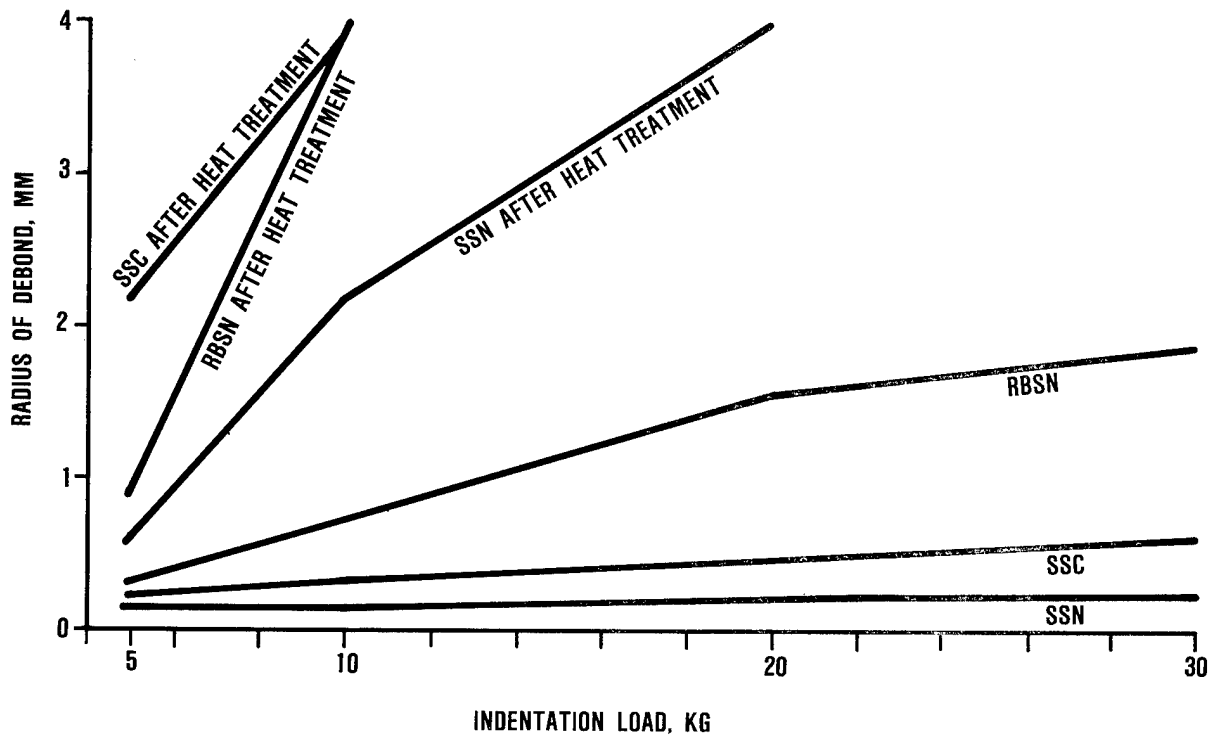
Figure 30. Results for substrates with 150 grit surface finish.

The 150-grit machined substrates were indentation and line contact tested for ZrO_2 coating adherence. Indentation results are shown in Figure 30. The as-coated adherence was good to excellent. After oxidation exposure, the adherence for RBSN, SSN, and SSC was poor. Contact tests were performed on oxidized specimens. RBSN and SSN exhibited fair adherence (spalled at 40 pounds) and SSC exhibited poor adherence (spalled at 30 pounds). The results suggest that 150-grit
